COILED TUBING

Integrated Services for Multi-well Coiled Tubing Campaign

Country: UK
 Year: 2021
 Technologies: Coiled Tubing • Real-time Coil • LiveLink • Fluid & N2 pumping • Thru-tubing tooling • Production logging & formation evaluation tooling • Downhole camera

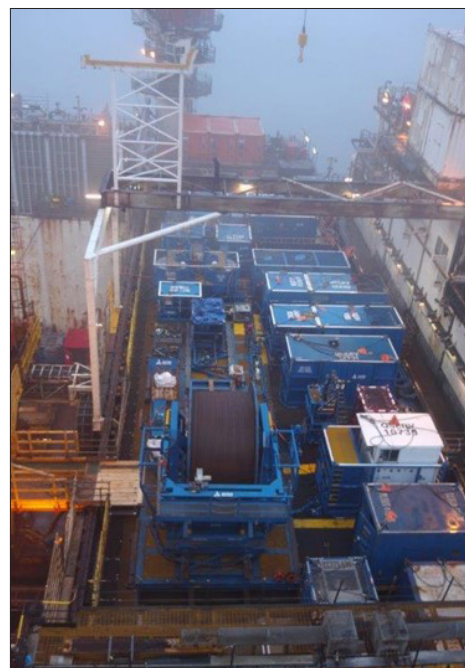
Coiled tubing equipment

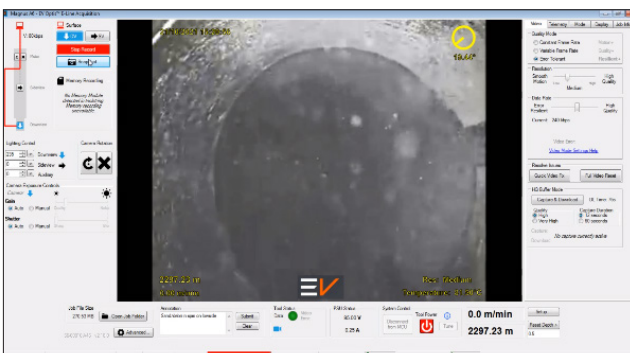
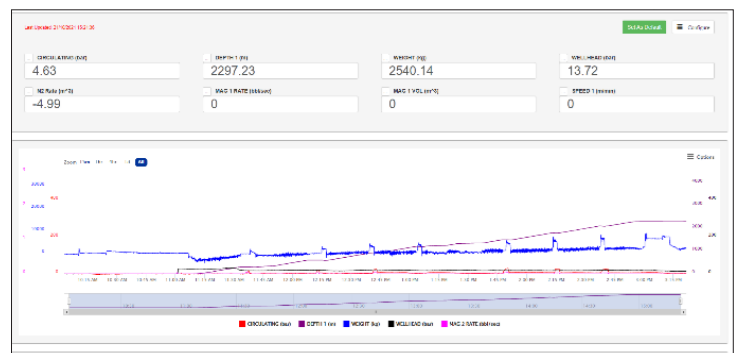
Live streamed data: LiveLink and real-time downhole camera working in conjunction to identify downhole issues

Well 4 – large, mobile debris (from suspected liner breach) blocking access and production from the reservoir. SRO camera to examine SPMs and liner damage then formation evaluation to determine water/solids remedial requirements.
