## TRACTOR CONVEYANCE

# Instrumented Tractor executes multi-run straddle deployment in deep water Malaysia

Country: Malaysia  
Year: 2019  
Technologies: **PowerTrac 318**

**PowerTrac** tractor with real time tension/compression data successfully deploys straddle assembly in deviated wellbore for gas shut-off intervention operation

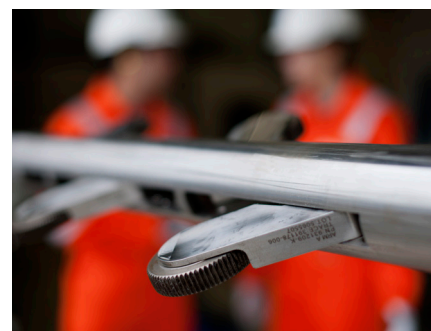
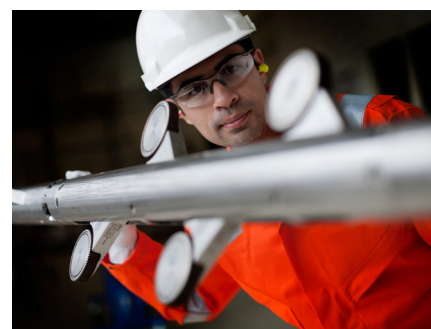
The instrumentation would provide real-time tension/compression data during the initial dummy run and for all subsequent straddle section deployment runs, data that would be particularly valuable during in-well assembly latching. The tractor itself would also be activated to assist with the assembly latching sequence if required. Real-time controlled release subs were incorporated in the string both above and below the tractor to assist with string recovery if a stuck assembly situation were to occur.

Due to e-line cable strength and rig up height limitations, the straddle, comprised of lower and upper packer and spacer assemblies, needed a total of six deployment runs to fully install. A thorough SIT (system integration test) was done onshore prior to mobilization to the wellsite. During the execution, a total of ~4500 feet of tractoring was required, conveying the multiple straddle and setting tool assemblies across the highly deviated sections of the well.

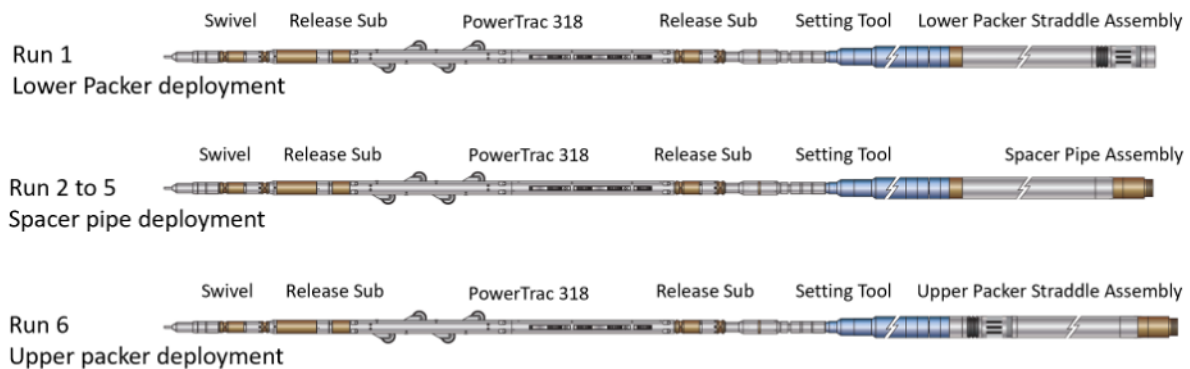
**Tractor – Straddle Packer Assemblies deployment toolstrings**
