## CASE STUDY

## Efficient Single run – Multi ball seat PRIME Milling Operation

Precise and efficient ball seat milling job enables full access for subsequent perforation operation, delivering improved injectivity in a critical well.

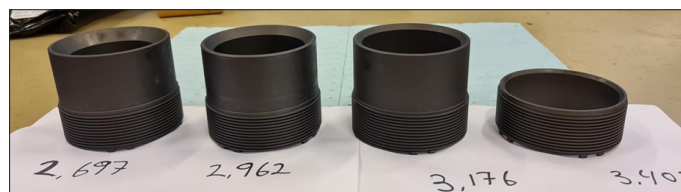
Ball seats provided to engineering for milling tests

Thorough pre-job tests were carried out at the Altus engineering facility on identical ball seats that were placed in a test-jig set up. During these tests, the key toolstring parameters were recorded as well as physical and visual inspections carried out to monitor mill wear as well as ball seat milling progress and condition. The time required to mill through each ball seat was also captured, this to determine the overall efficiency of the milling solution, and to determine optimised tool parameters to be used for the actual operation.

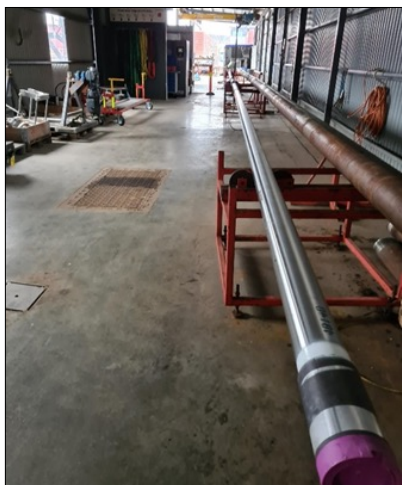
Test-jig set up

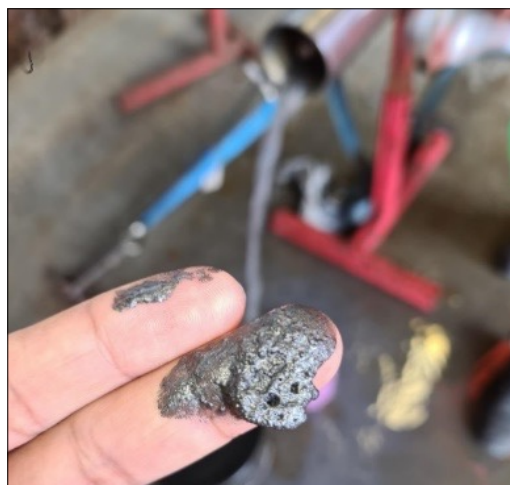
The Swarf produced by the milling operation was found to be powder like, leaving no concern with regards to hinderance of the subsequent electric line perforation runs or a detrimental impact on the well injectivity.

Swarf collected following milling tests
